**NASA TM X-52990**

# SHOCK AND VIBRATION TESTS OF A SNAP-8 MERCURY PUMP

by Cecil L. O'Dear and Robert D. Follett Lewis Research Center Cleveland, Ohio

### ABSTRACT

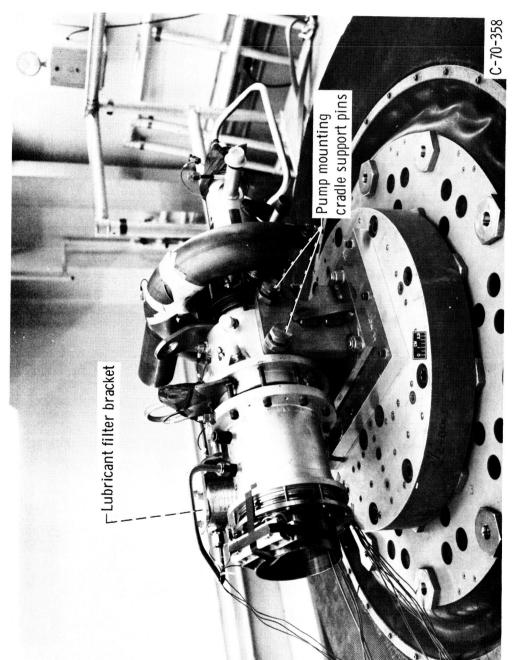
Upon removing the lubricant filter bracket (fig. 1) from the housing group, it was determined that the mounting bolt torques had decreased

The pump-mounting-cradle support pins (fig. 1) which secured the main housing in the support cradle for this test were heavily galled on the pump side and less damaged on the motor side. The cradle and pins are test support fixtures and are not a part of the pump.

Figure 1. - SNAP-8 mercury pump.
